**29. Mitteldeutsches Bau-Reko-Kolloquium  
Wittenberg (Sachsen-Anhalt), 21. April 2010**

**Historical structures for modern times, secured by respectful engineering support**  
*(Historische Tragwerke in der neuen Zeit, gesichert durch respektvolle ingenieurmäßige Begleitung)*

Dionys Van Gemert, Sven Ignoul, Gert Heirman, Kris Brosens  
K.U.Leuven & Triconsult nv, Belgium

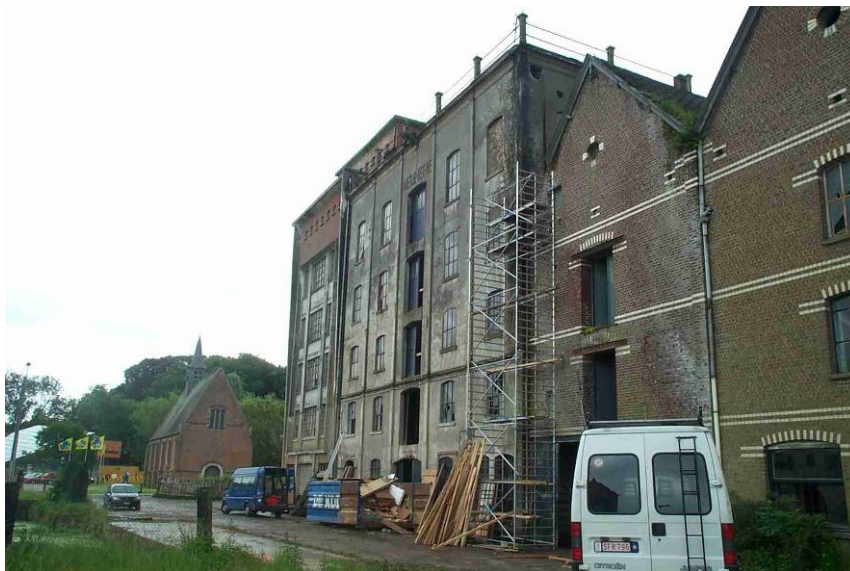
**Figure 1** Steam Mill at Overijse (constructed 1902)  
*Dampfmühle in Overijse (Baujahr 1902)*

During the assessment, the strength of the reinforced concrete beams and columns has been determined. Because the building is listed, the number of destructive tests had to be minimized. The concrete compressive strength is determined using a combination of both destructive (DT) and non-destructive (NDT) tests: compressive tests on drilled cores (DT), ultrasonic testing (NDT) and sclerometer (rebound hammer) testing (NDT).

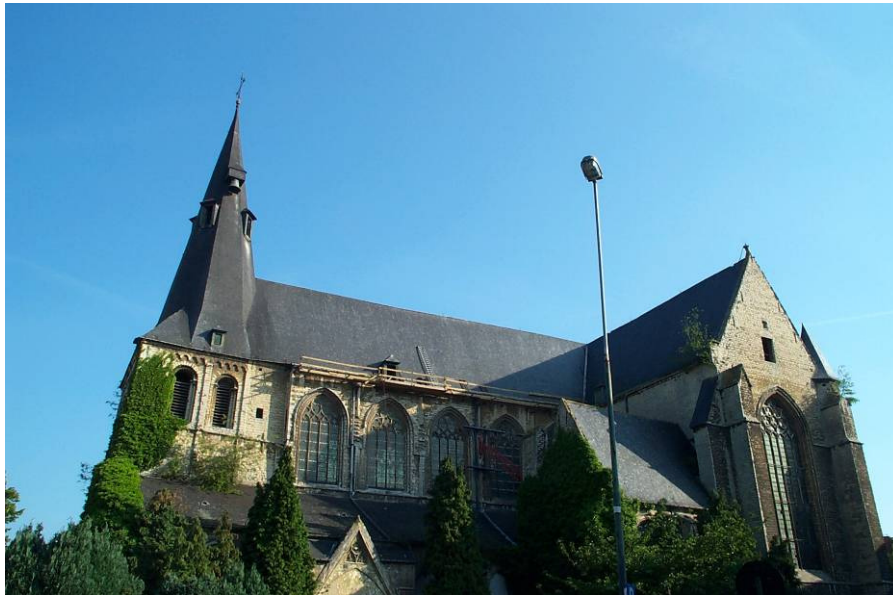
The structure itself is located on an earlier swamp, reclaimed by the monks at the time of construction. The load-bearing capacity of the subsoil is limited, causing large differential settlements. At several occasions in the past, restoration works took place. Due to the excessive cracks observed however, it was decided in 1963 to close the church envisaging its structural collapse, to remove the severely cracked masonry vaults of the side naves and to shore up the pillars of the main nave.

was made with irregular intervals, and finally a profound study of the church deformations was executed by Triconsult nv in 2007 [5]. This study revealed that the crack patterns and deformations did not at all correspond to the assumed deformation scheme given in Figure 5.

**Figure 4** Saint-James' church: Romanesque western tower; Gothic nave and transept  
*Sankt Jakobskirche: Römischer Westturm; Gotisches Schiff und Querschiff*

The tower is not leaning and pushing against the nave. Therefore, the concrete stiffening columns and the stiffening trusses are not needed. The preliminary works, executed in the period 1963-1971, are now a major part of the restoration problem or project. The therapy will essentially consist of the following different phases and measures: strengthening of foundations of columns and tower; consolidation of nave columns; crack repairs; removal of concrete and steel stiffening elements.

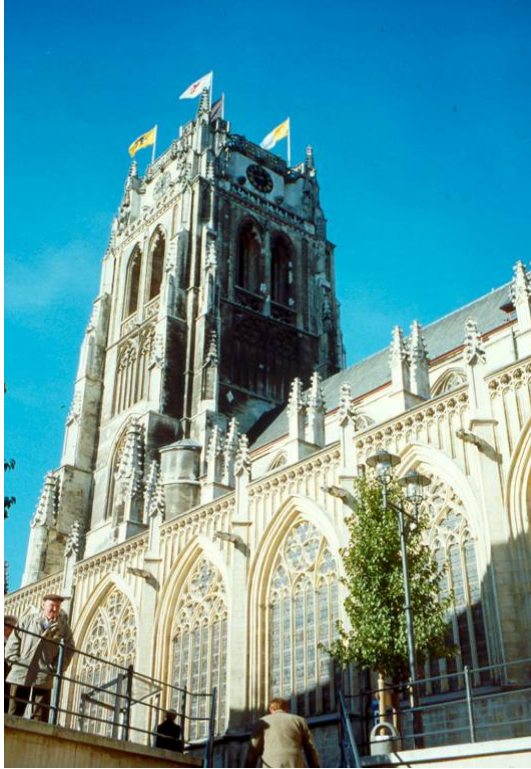
**Figure 9** South view of Basilica at Tongeren  
*Südsicht auf die Basilika von Tongeren*

From existing small cellars it was estimated that foundation depth of walls and columns would be about 2.7 to 3.0 m. The necessary excavation depth for an accessible cellar, taking into account the necessary space for a roof plate and new flooring system for the church, would be 3 m. To give the visitors the real feeling of an archaeological site, and not of a crypt under the church, it was decided to excavate the central nave and the adjacent aisles as well as part of the choir. This presents a surface of about 20×40 m<sup>2</sup>, in which the column footings and the wall foundations would be stand-alone elements. Removing of the soil around the foundations also takes away the constraining action of the soil on the foundation masonry. Moreover, the direct foundations at depths of about 3 m than become direct foundations on the soil surface.

The load carrying capacity of surface foundations is very limited and uncertain, and would certainly lead to excessive differential settlements. Moreover, the unconstrained rubble masonry of foundations has nearly no strength. Both effects significantly endanger the structure, leading to an almost certain collapse. Therefore the project was preceded by a preliminary investigation to reveal the composition and quality of the foundation masonry, and to study possible injection grouts for consolidation of the masonry, to strengthen it sufficiently to be able to transfer the anchoring forces of the micro piles, Figure 10. The underpinning of all the columns and walls in and adjacent to the excavation will avoid such differential settlements. The micro piles must be anchored in a stable masonry, able to take up the concentrated forces of 200 kN each from these piles [6]. Therefore the masonry walls were injected with mineral grout.

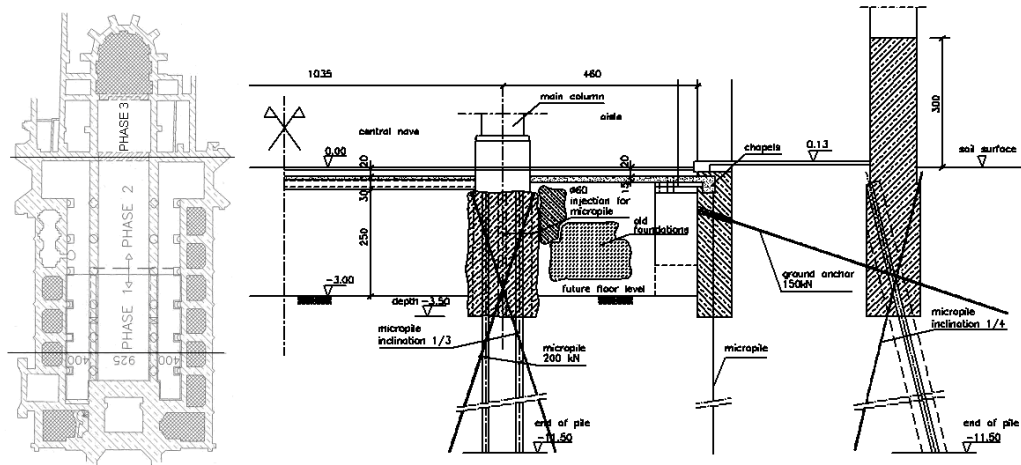
**Figure 10** Left: Plan of the church with excavation phases I and II. Right: Cross-section of the archaeological cellar.

In phase I, a pure cement grout was used for the consolidation of the foundation masonry. This grout had been developed for the consolidation of the tower masonry in 1993 [7]. The “injectability” of a cement grout depends, among others, on the fineness of the dispersion of the cement particles in the water phase. The addition of superplasticizers and stabilizers prevents the dispersion from coagulation and segregation. The injected cement-based grout was a mixture of cement, admixtures and water (see also Table 1, composition 1).

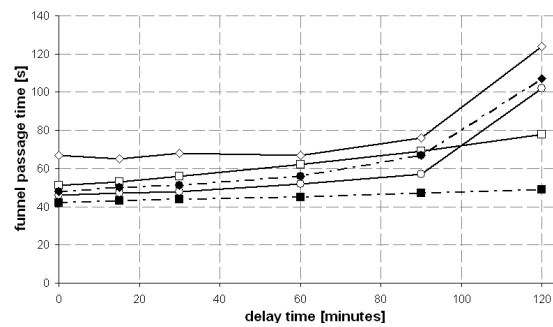
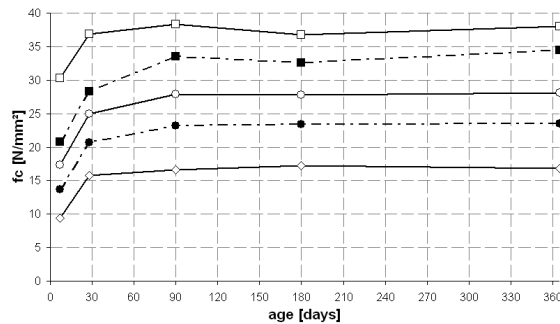
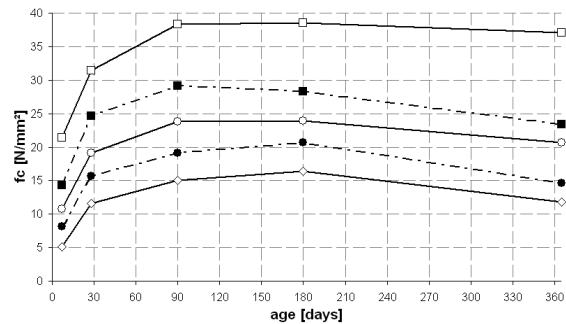
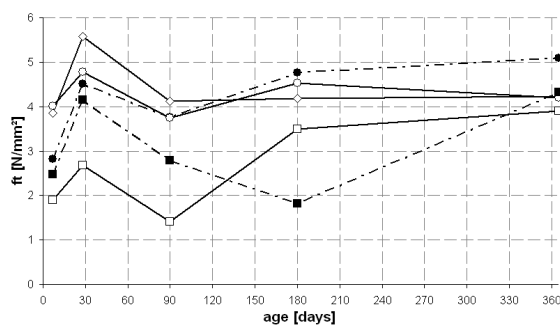
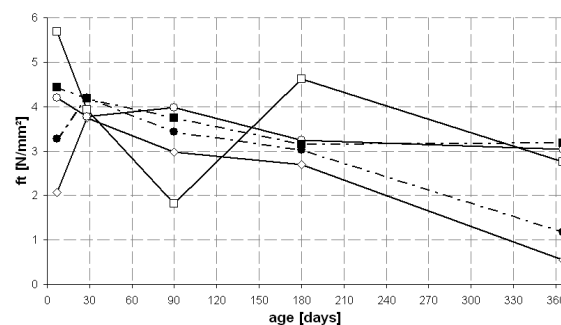
**Figure 12** Marsh-cone flow times and compressive and flexural strength of the different compositions

The fluidity test is performed with a Marsh funnel Viscometer according to the American standard ASTM C 939:1987. The Marsh cone used was an OFITE and is calibrated so that it takes  $26 \pm 0.5$  s for 947 ml of water ( $21 \pm 3^\circ\text{C}$ ) to pass the funnel. Figure 12 gives the Marsh cone flow times of the different compositions tested for phase II. The flow times were measured after 0', 15', 30', 60', 90' and 120'. It was the aim to develop a grout which fluidity stays constant during the first one and a half hour and then decreases rapidly. Figure 12 clearly shows that compositions with an air hardening lime content above 30% fulfill this special condition needed to prevent the filling of the valuable artefacts.

The compressive and flexural strength tests were executed after 28, 90, 180, 365 d. Figure 12 gives the evolution of the compressive and flexural strengths of the different compositions of both groups. Higher cement content results in higher compressive strengths. The compressive strength of group B tends to decrease slightly after a year. The flexural strength depends on the amount of cement and the relative humidity. Group A (R.H. > 96%) shows no decrease of the flexural strength after 365 days. For group B, a cement content of 70% is observed to be a minimum to prevent dropping of the flexural strength. The drop of flexural strength is probably due to microcracking occurring at the interior of the samples. It is assumed that the reason of this microcracking is caused by drying or by the difference between areas of the grout situated towards the exterior of the specimen that are carbonated and other areas towards the interior, that are still hardening. Hydration causes chemical shrinkage and induces tensile stresses (and thus microcracking) at the interface of a carbonated (and thus inert) part of the material and a non carbonated (and thus hydrating) part of it. After considering all the objectives, it was decided that composition 4 (70% cement, 30% slaked lime) corresponded best with all the requirements stated above and therefore was used on site.

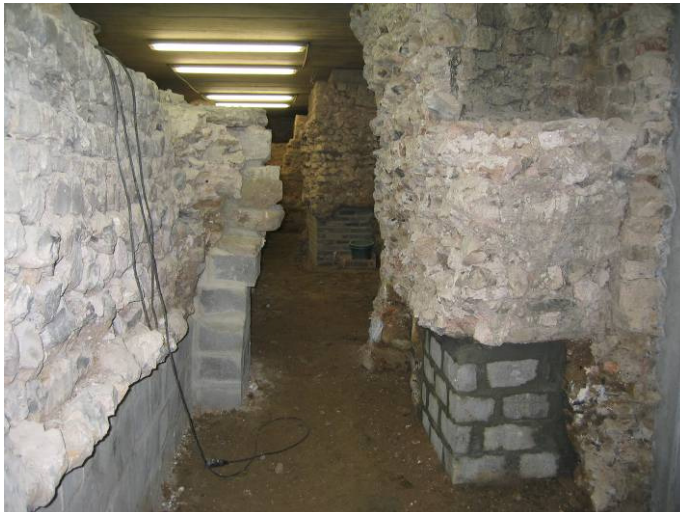
**Figure 14** Archaeological cellar, situation March 2007

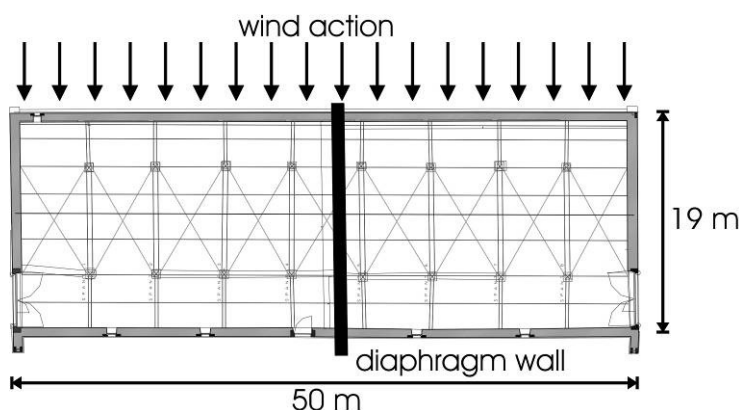
The large structure (length: 50 m, span: 19 m and height: 15 m) suffered from large lateral wind actions. A lot of joints were inadequate to take the induced forces. Also the masonry walls seemed to be bulged due to the wind load on the roof structure in the past. This was counteracted by the construction of a diaphragm wall and buttresses, as shown in Figure 22.

**Figure 22** Diaphragm wall  
*Diaphragma Mauer*
